**SPACE SHUTTLE BODY FLAP ACTUATOR BEARING TESTING FOR NASA RETURN TO
FLIGHT**

ABSTRACT

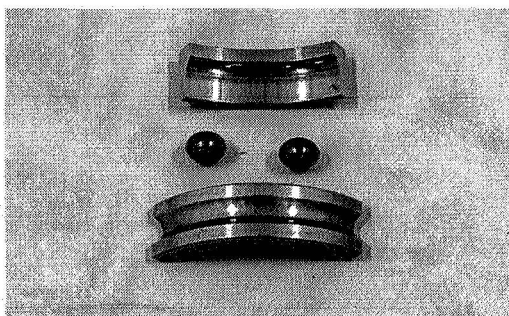
The body flap (BF) supports control during critical descent maneuvers of NASA's Space Shuttle orbiter. Four hydraulic actuators on a common shaft control the operation of this body flap. During routine inspection of these actuators, one of the input shaft bearings was discovered to have blackened balls (See Figure 1) the actuator had completed approximately 20 missions and also exhibited minor corrosion and plastic deformation from disassembly. It was deemed unacceptable for service and was replaced and the used grease was discarded. A destructive analysis was performed on this bearing. SEM examination revealed that the balls were worn and pitted and micro-hardness measurements indicated no softening at the surface. Metallographic examination revealed the proper microstructure for this alloy (52100) and heat treatment. It was concluded that mild mechanical wear caused the blackening.

Figure 1. Shuttle Body Flap Actuator bearings with Blacken Balls
